# TADCO LAMINATION PLATES

## PERFORMANCE ANALYSIS

Teradyne  
Circuits Division  
April 13, 1993

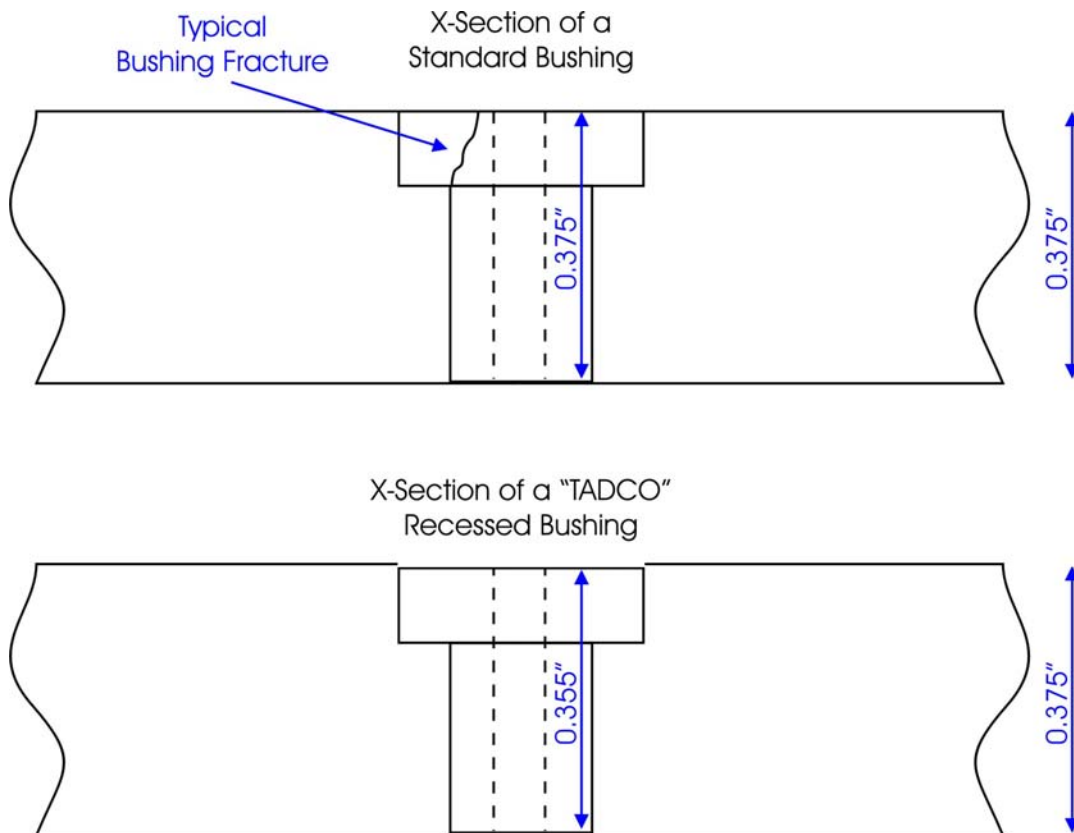
TADCO has designed in their plates a specially sized bushing that lasts longer than other manufacturer's bushings. This bushing is shorter than the thickness of the lamination plate and is recessed into the plate. This shorter bushing design leads to a longer-lasting bushing. The bushing lasts longer than the industry standard bushing because the lamination press pressure is not exerting force on the HAT portion of the bushing. The recessed design eliminates the lamination press pressure that fractures the hat of the bushing. The first diagram below illustrates the typical bushing failures that we have experienced with other brands of lamination plates that do not use the TADCO recessed bushing design.

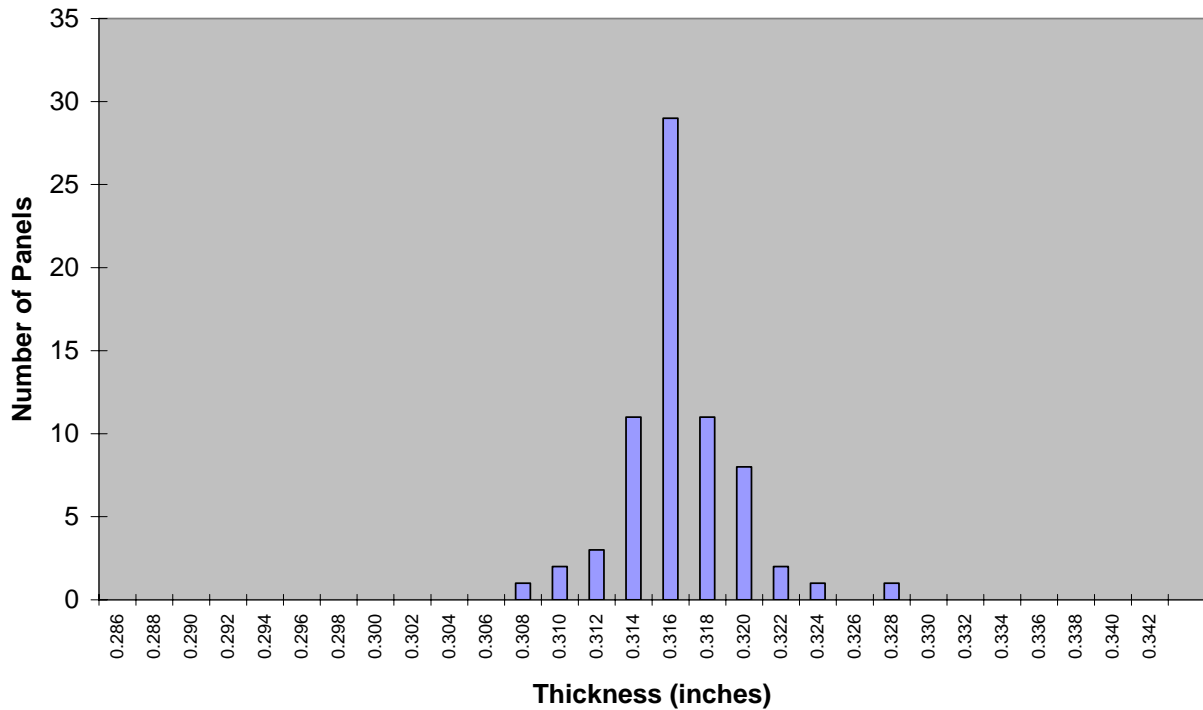
### Panel Thickness Histogram

The flatness of these plates is critical to ensure good results on the final product. The following is a histogram of the panel thickness for a 0.315" thick backpanel that Teradyne produces. The tight thickness distribution illustrates little variation within all plate sets used. This panel covers a large amount of real estate; the panel size is 18" x 41". Achieving world class results of a  $C_p=2.83$  would only be possible if the plate sets were within the inspection criteria I described earlier. (Note:  $> 1.33 C_{pk}$  is 6 sigma: considered world class.)
